Large Barn, Hall Farm,  
Hall Lane, Stanton Street, Suffolk:  
An Historic Building Record

*This document provides the results of a programme of historic building recording carried out at English Heritage (2006) Level 3 of the Large Barn, Hall's Lane, Stanton Street, Suffolk. It has been prepared as a record and condition assessment of a building on the English Heritage Buildings at Risk Register for the benefit of the owner and the community, were the building's condition to deteriorate. The record and assessment were made in October 2012.*

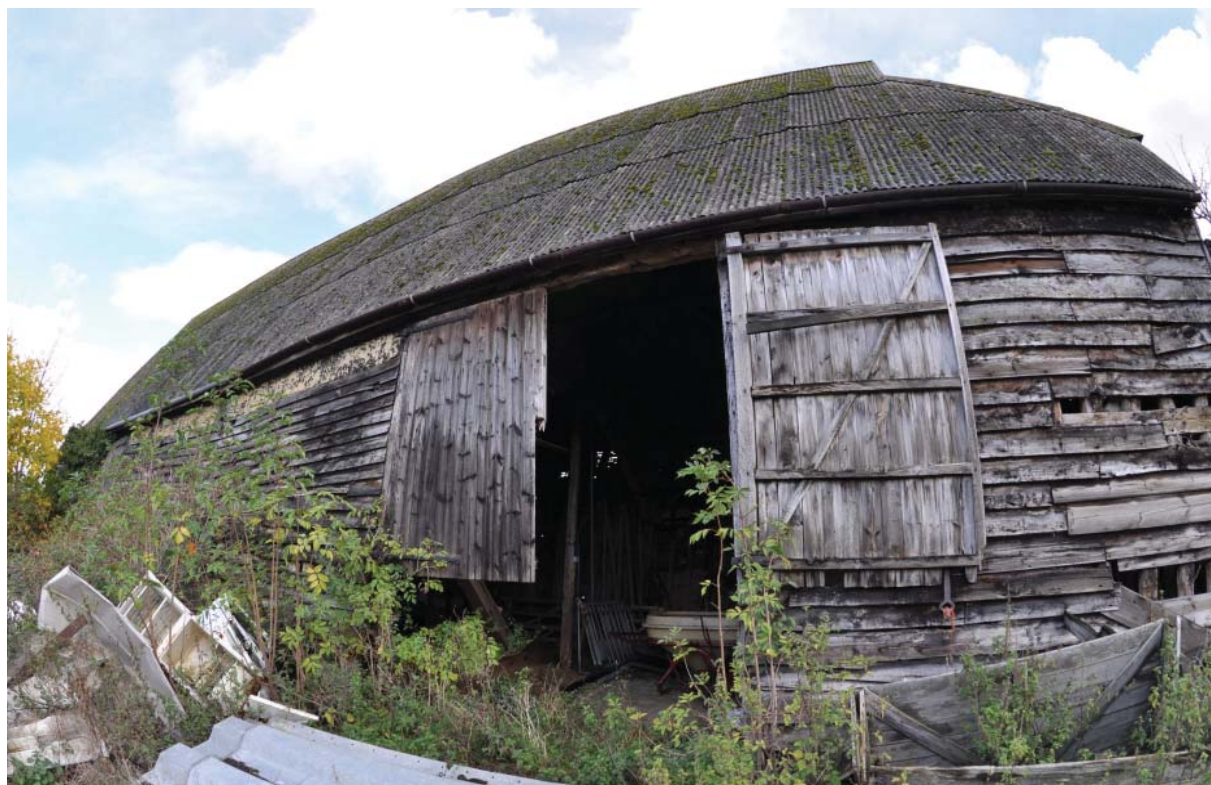
The condition of the barn is of concern. It is currently propped up on the west side as a result of the barn roof shifting ~1m to the east along the northern 2/3rds of its length. Despite the movement, the roof is currently wind and watertight.

West Face of the Barn (Fisheye Lens)

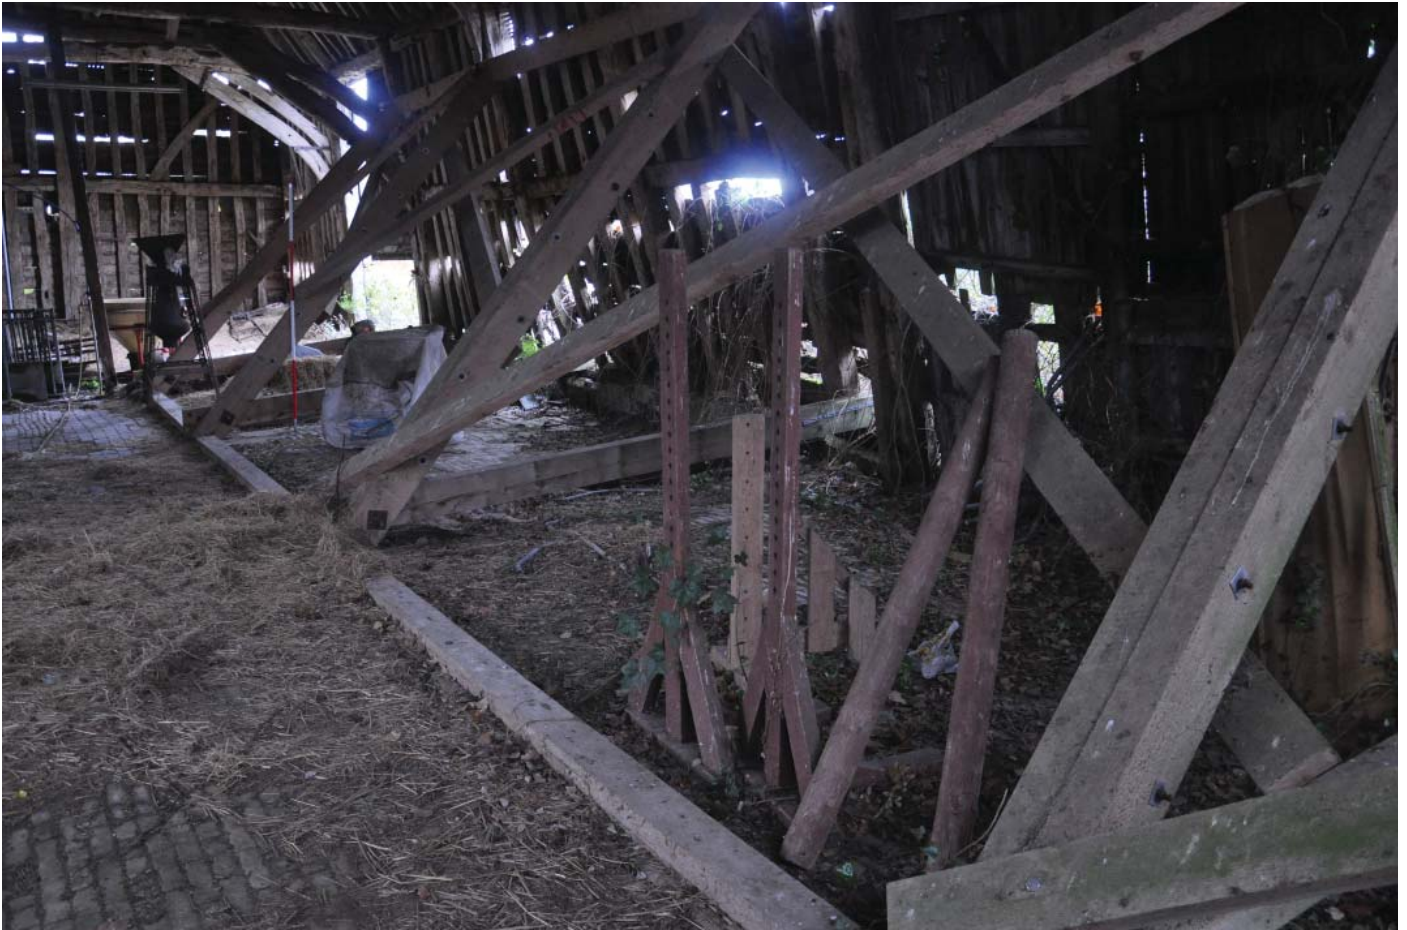
Prop work holding up the West Side of the Barn

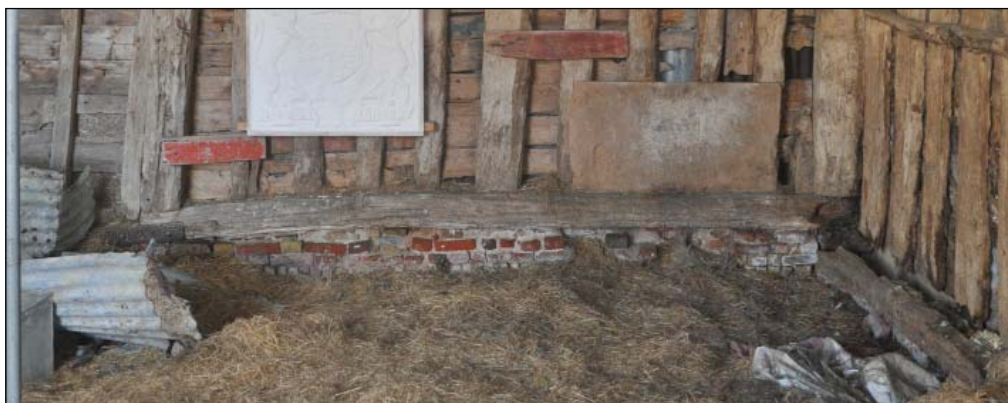
Most Intact Section of Footing and Sill Beam

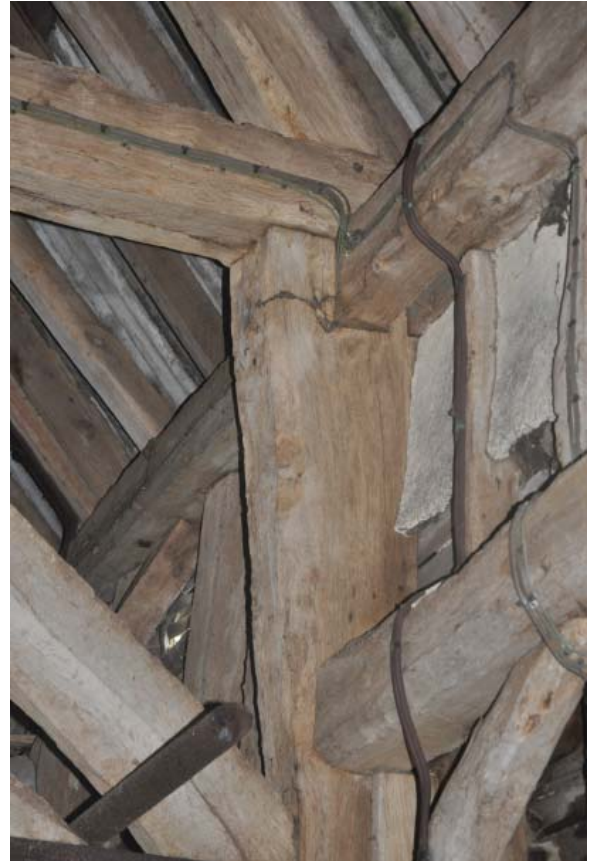
Truss 2 Eastern Post, Tie Beam and Rafter Joint

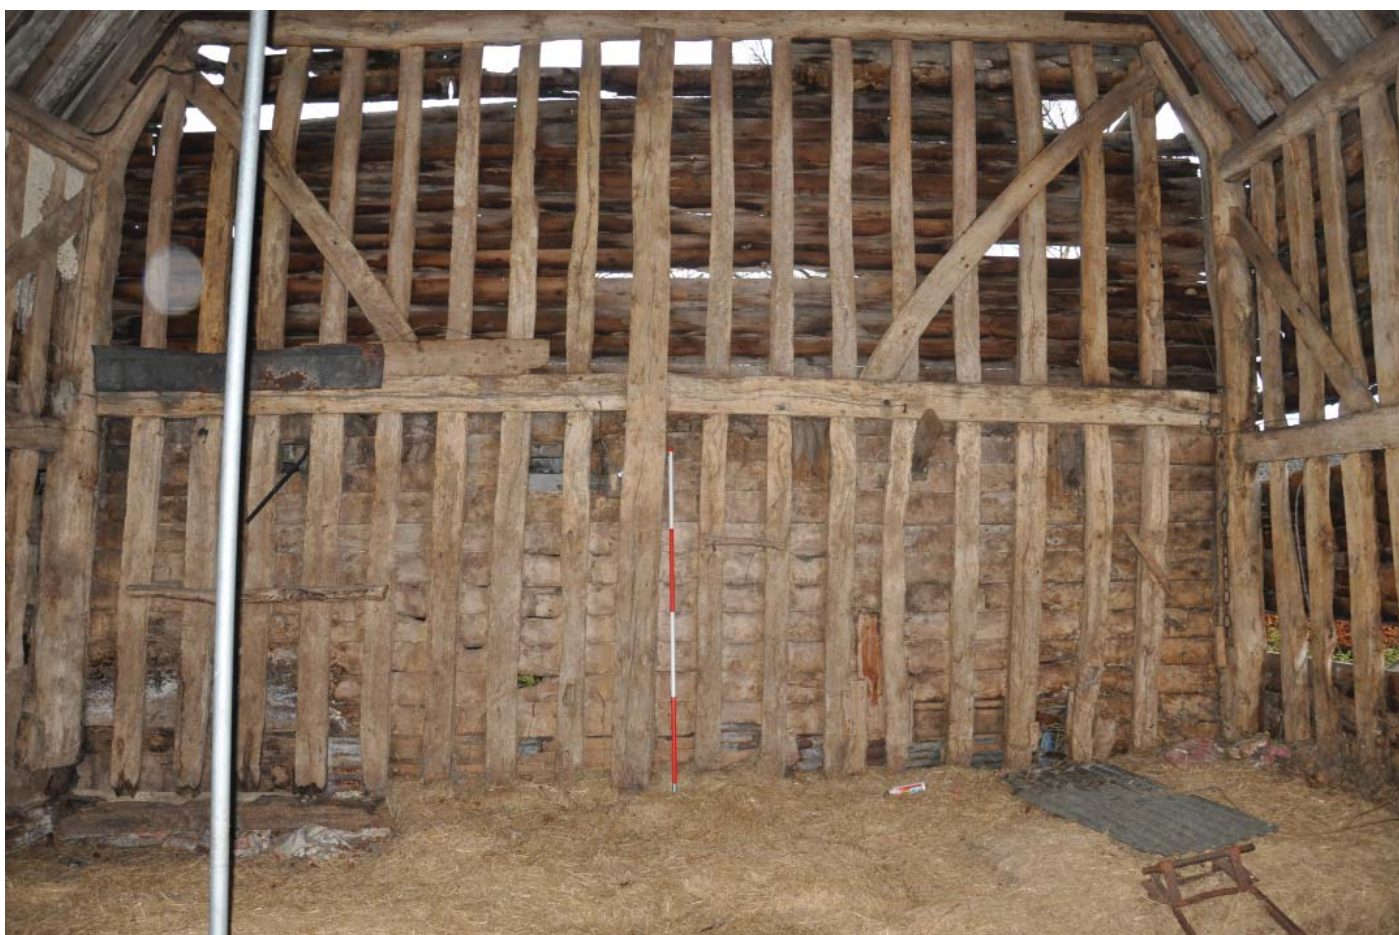
Bay-1 South Wall Internal Elevation

Each end wall topplate is one metre higher than the topplates of the side walls. This is accommodated by the corner posts being knee principles, bending inwards at the height of the side walls topplates towards the east or west. This element suggests that the roof has always been hipped in one form or another.

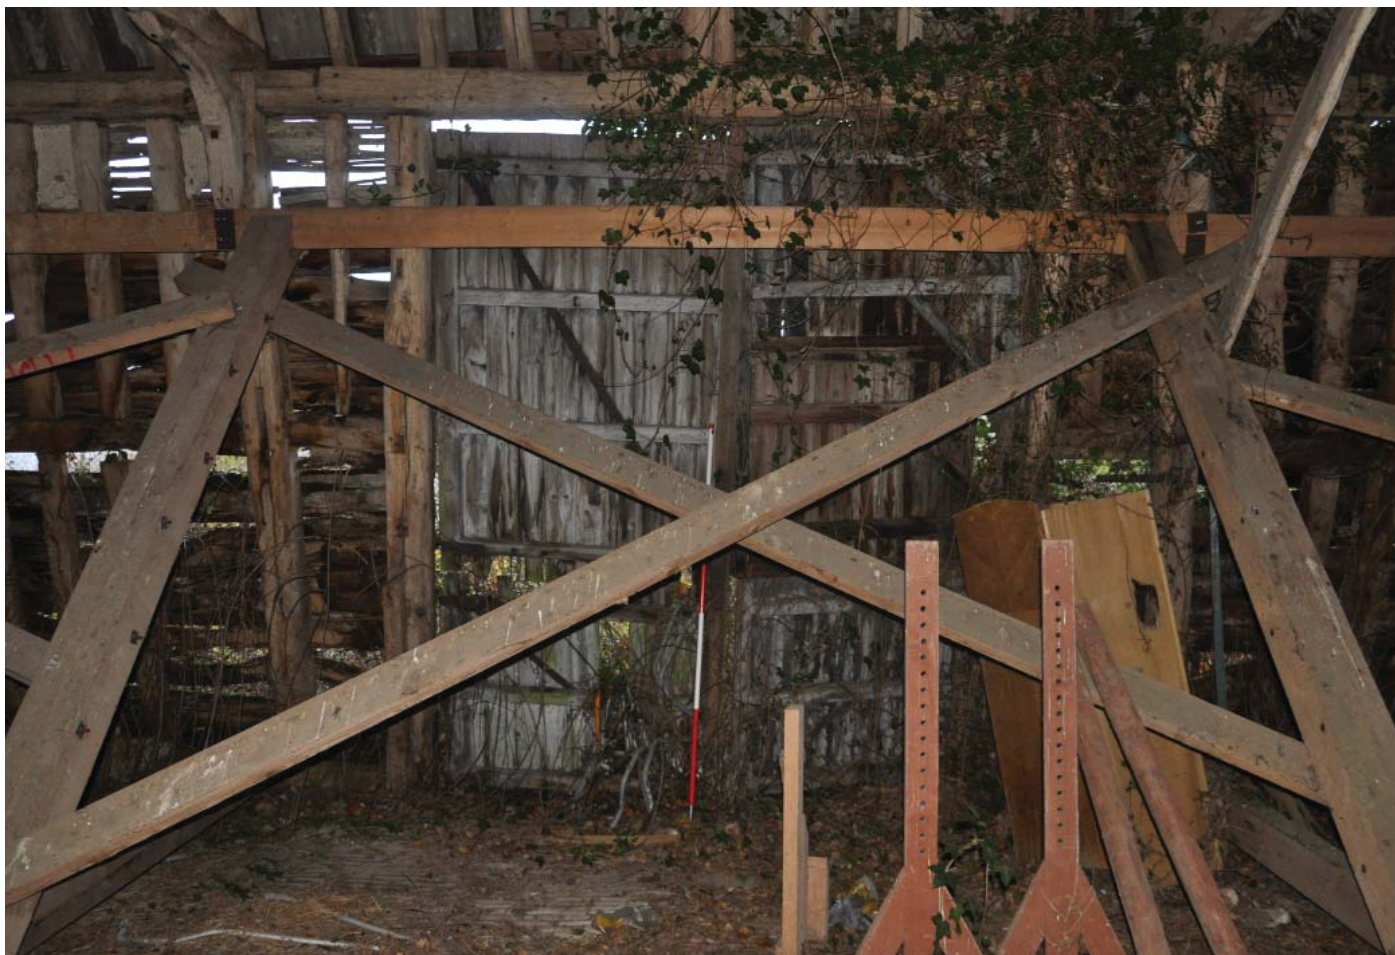
Doorway 2 Overview

In an identical form as doorway 1, on either side of doorway 2 there are posts that have been reused from another location. The post to the south most starkly appears to once have been a topplate with a series of sockets designed for joists.

This doorway however differs to doorway 1 in a number of key ways; between the inserted posts and their adjacent trusses there are mid-rails continuing on from the mid-rails in bay 4; centrally between the trusses and beneath the principle rafter there is a large mortice hole which I believe once held a large post that would be the main post of an intermediate truss, the same as in bays 3 and 4. All the mortice holes that are visible in the topplate and the posts of trusses 4 and 5 are in exactly the same positions as those holding timbers in bays 3 or 4.

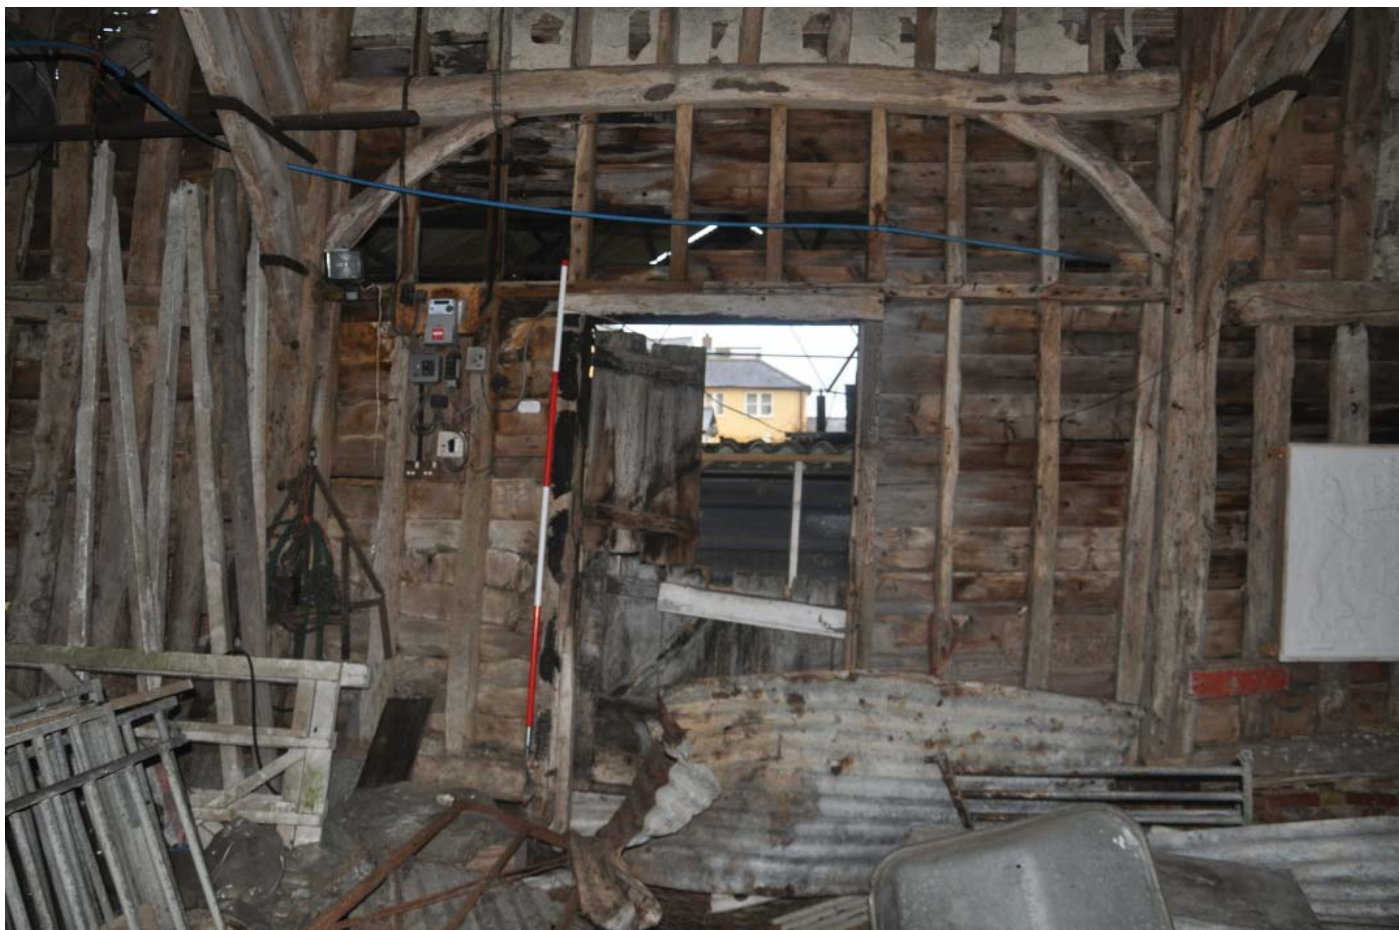
Doorway 3 Overview

Between trusses 1 and 3 there is a lintel 0.8m above the height of the mid-rails in bays 1 and 3. This lintel is supported by a pair of arch braces, one either side. Above this lintel there are 9 evenly spaced studs. Originally beneath the lintel there was a large wide opening, possibly opening into a storage bay on the site of the modern shed that is currently there. There is no evidence in the posts that this opening had doors. It should be noted that it was not possible to examine the external face of these timbers or the surrounding walls due to the modern shed, and so these possibilities cannot be confirmed.

Today, the space beneath the lintel has been filled in with a series of 10 studs that are distributed so that the first and last stud are next to trusses 1 and 2, and so that studs 4 and 7 form the sides of the current doorway. There is a thin timber lintel above the doorway that extends from truss 1 to truss 2. A large iron bracket is screwed onto the internal face of the sill beam. This would have once been attached to the sill beam extension that continued up to the current doorframe. This has since rotted away, leaving the studs and door surround on the south side floating.

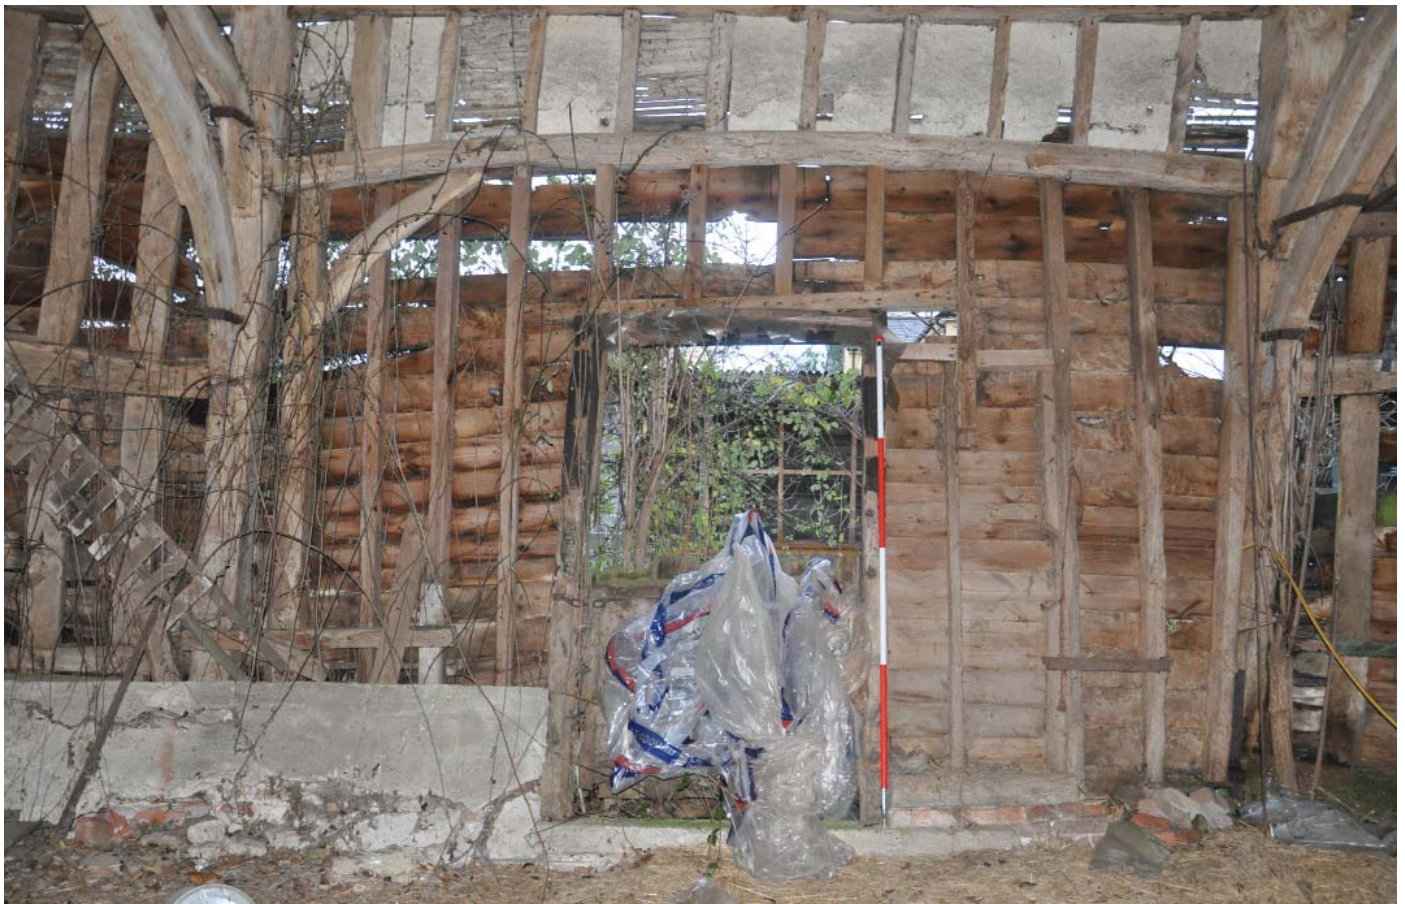
Doorway 4 Overview

The lintel that crosses from truss 4 to 5 has 10 evenly spaced studs above. Above the mortice and tenon joint at the northern end of the lintel, the post of truss 5 has had a triangular section cut to allow the insertion of the lintels tenon into the mortice.

There is an arch brace holding up the lintel, as there is on doorway 3, but it is anchored into the first stud rather than the truss. There are twelve studs between trusses 4 and 5, with the first being tight against truss 4 and the last being a few inches from truss 5. Studs 5 and 8 form the sides of the current doorway. There is a short lintel across the doorway itself. Half way between trusses 4 and 5 there is a large mortice hole in the topplate directly beneath the principle rafter that I believe once held the tenon of a principal post of an intermediate truss. The weatherboarding has a straight vertical cut either side of bay 5.

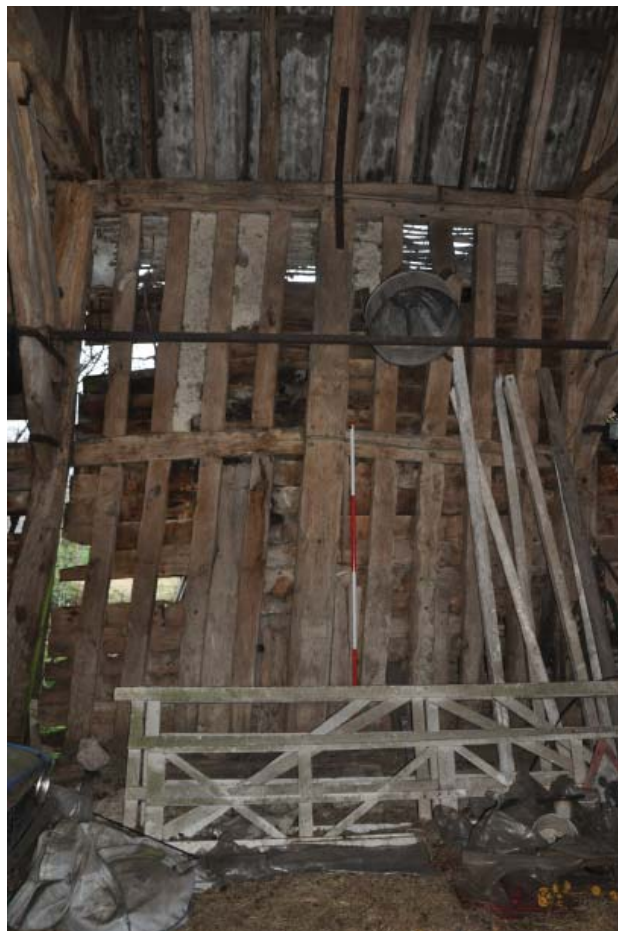
The barn walls are covered in weatherboarding on the outside. This has been at least partially replaced. It is difficult to tell to what degree, given its general poor condition and the quantity of foliage and detritus that surrounds the barn. What is clear is that at some time there have been large sections of boarding removed by straight vertical cuts (visible on the left hand side of this photograph). The new boarding has been put in place abutting the old, leaving straight joints in the boarding. One of the main purposes of the weatherboarding, other than to keep the weather out, is to spread the load of the wind force on the sides of a building. In this case, the effectiveness of this function has been dramatically reduced, as the spreading of the load stops at the straight cut. The weatherboard condition is generally poor, particularly at the northern end of the barn where there has been the most movement of the barn.

Bay 4 - A Typical Section of Wall Frame

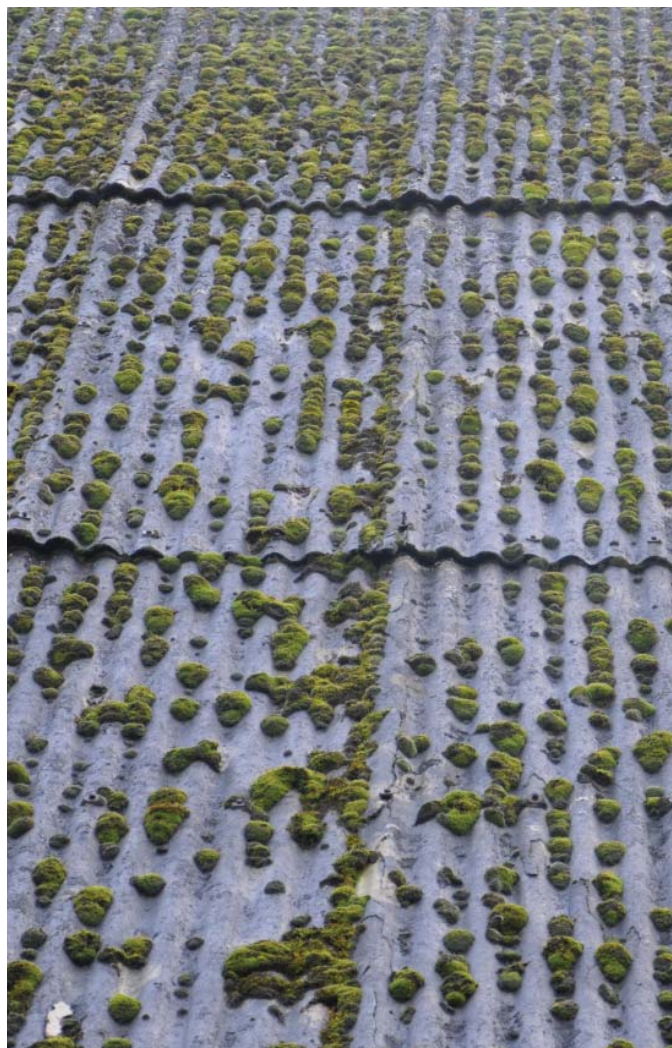
A Sample of Corrugated Roofing

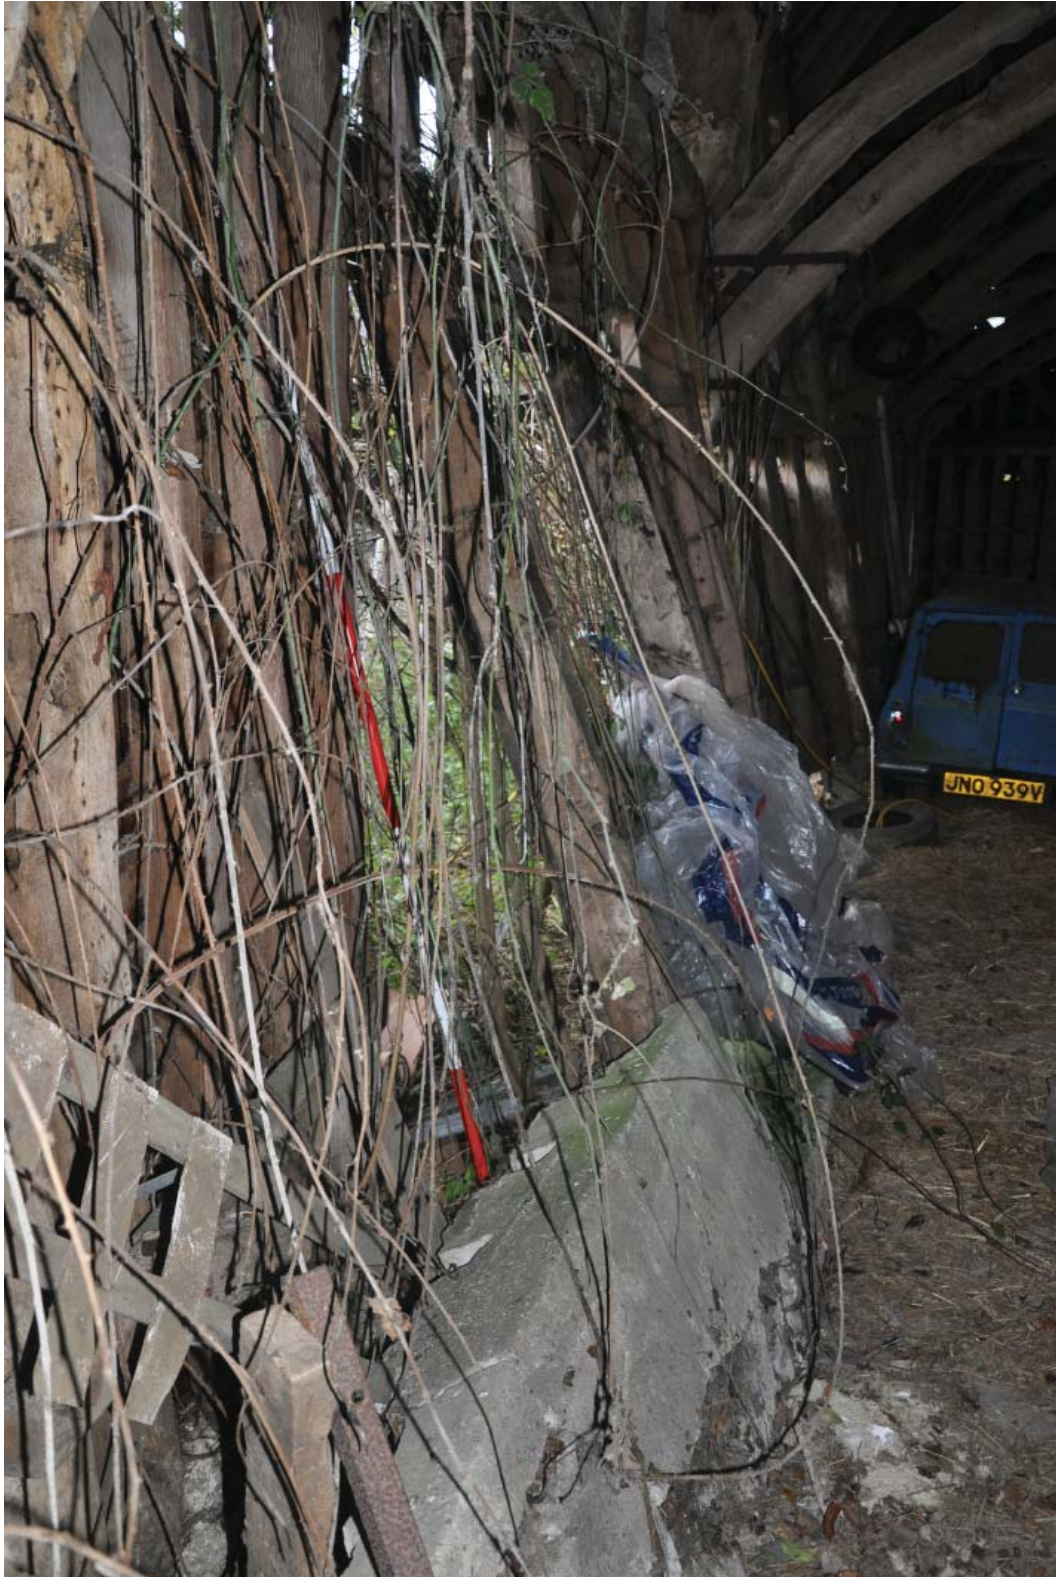
It is likely that if something fairly serious is not done in the near future the barns condition will deteriorate further at an increasing rate, eventually resulting in the barn's collapse.

Bay 5 - Wall Frame Leaning to the East
