Historic American Timber Joinery: A Graphic Guide | 2004-08

HISTORIC AMERICAN TIMBER JOINERY

A Graphic Guide

By Jack A. Sobon

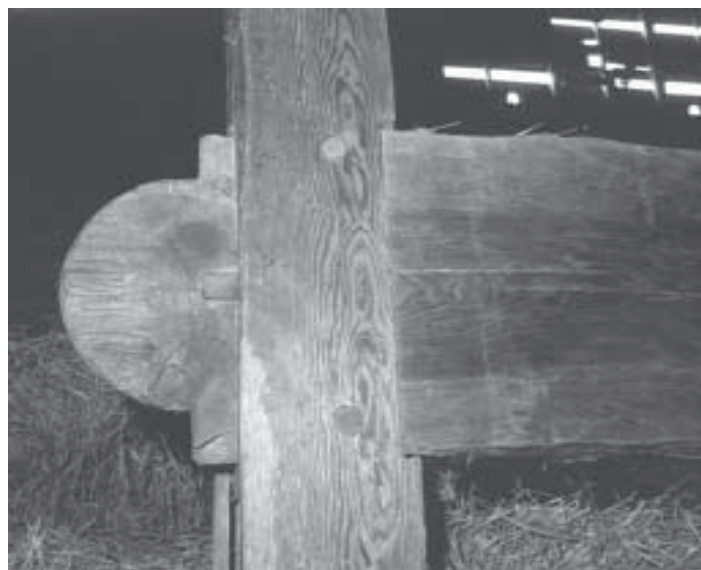
This unusual tenon profile appears on three Dutch barns in Coeymans, N.Y., likely the signature of a particular builder.

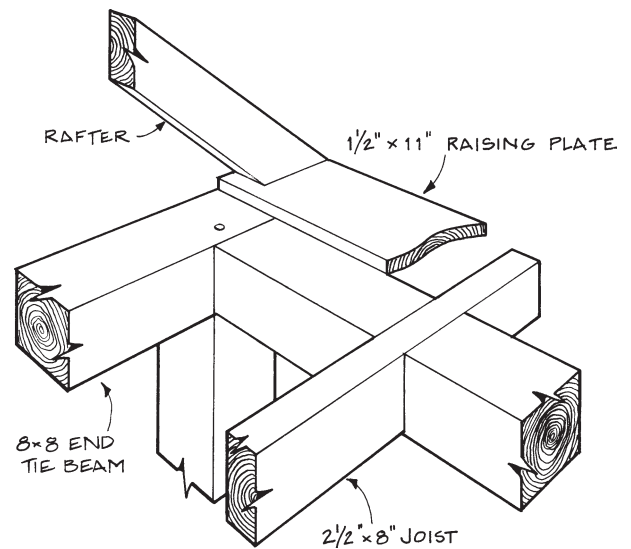
Fig. 8. A plank called a raising plate was sometimes nailed to both ties and joists, and rafters were nailed to it in turn. Attic floor boards butted to the plank. This arrangement was found in a 1791 house formerly standing in Cheshire, Massachusetts.

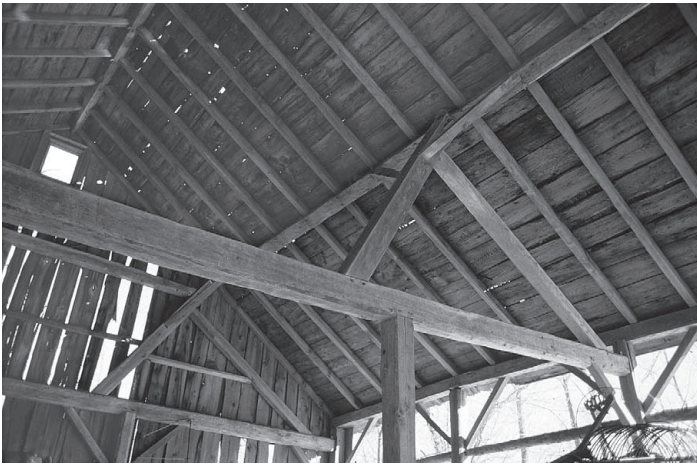
Mid-19th-century Hinsdale, Massachusetts, barn before dismantling. The continuous purlin plate assembly is canted perpendicular to the roof, and the purlin plate is flush with the roof. The rafters tenon into both upper and lower faces of the purlin plate.

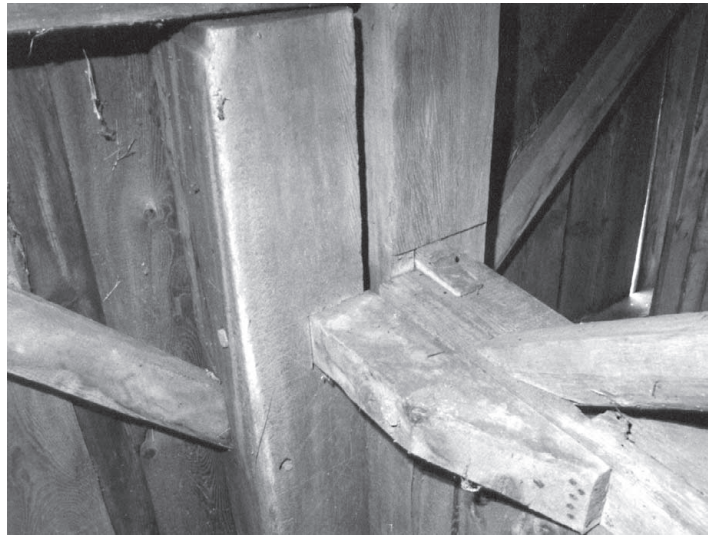
When the builder added to this barn in Savoy, Mass., he saved on a new 30-ft. tie beam by framing a piece into the post and pinning and nailing it to the existing barn's tie beam. Sheathing remains in place below tie beam; shallow wedge for dovetail tenon emerges on surface.

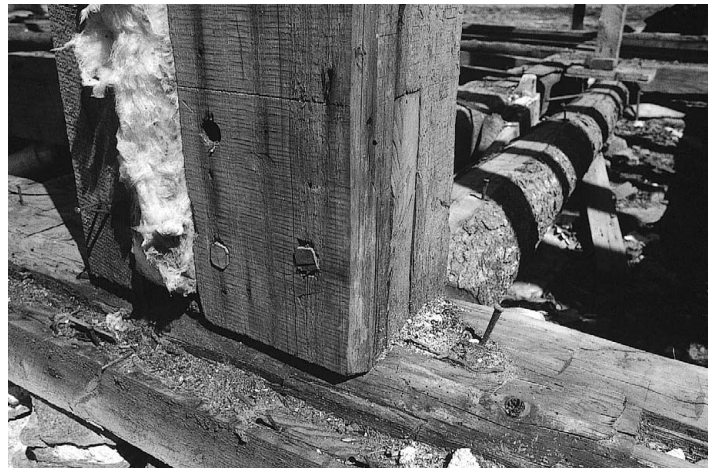
A free tenon in the bottom of a post in this house in Windsor, Mass., may be a repair or a fix for a mistake. Shadows are cast by joists above.

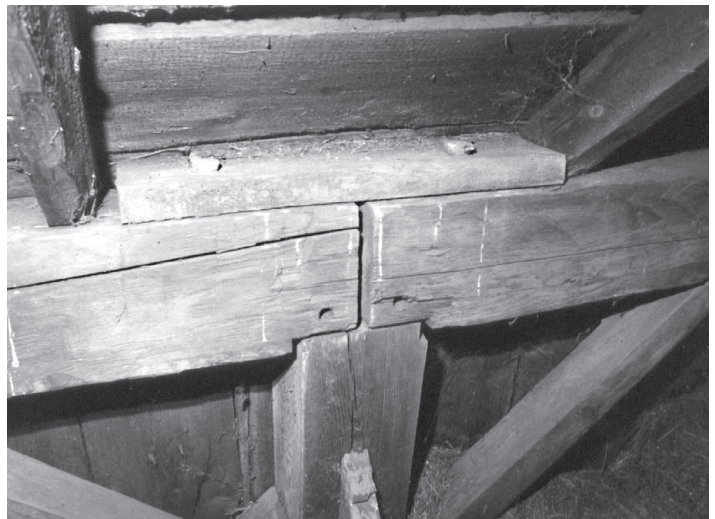
This strange arrangement in a barn in Rochester, Vermont, uses the post-top tenon as a sort of free tenon to join the plates, though pins are invisible. The builder must have realized the inherent weakness of the connection and added the fish plate on top, secured with two pins.

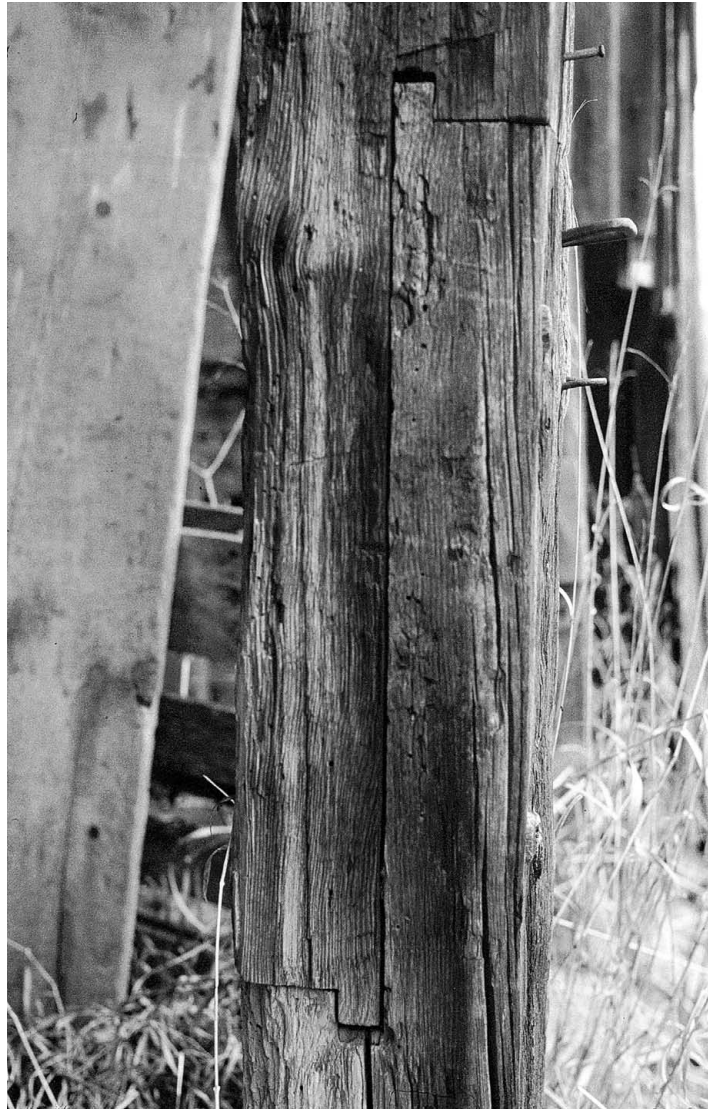
At top, bladed scarf with key, barn sill in Woodford, Calif. The sill is 8x8 Ponderosa pine, the scarf only 16 in. long. Top right, a bladed scarf used to repair a 7½ x 9½ post in a barn in Buskirk, N.Y. The tenons are 1 in. thick and 1 in. long, the scarf 23 in. long, with four pins. Above, a stop-splayed, undersquinted and tabled scarf with key used in a 6½ x 13 truss chord in the 1796 Cabildo in New Orleans (roof burned 1988, reconstructed 1992). There is barely a splay, and two forged iron straps still hold the joint together. At right, this unusual stop-splayed, undersquinted and tabled scarf in Pine Plains, New York, did not employ a key: the halves had to be slid together sideways.
