Large Barn, Hall Farm,  
Hall Lane, Stanton Street, Suffolk:  
An Historic Building Record

*This document provides the results of a programme of historic building recording carried out at English Heritage (2006) Level 3 of the Large Barn, Hall's Lane, Stanton Street, Suffolk. It has been prepared as a record and condition assessment of a building on the English Heritage Buildings at Risk Register for the benefit of the owner and the community, were the building's condition to deteriorate. The record and assessment were made in October 2012.*

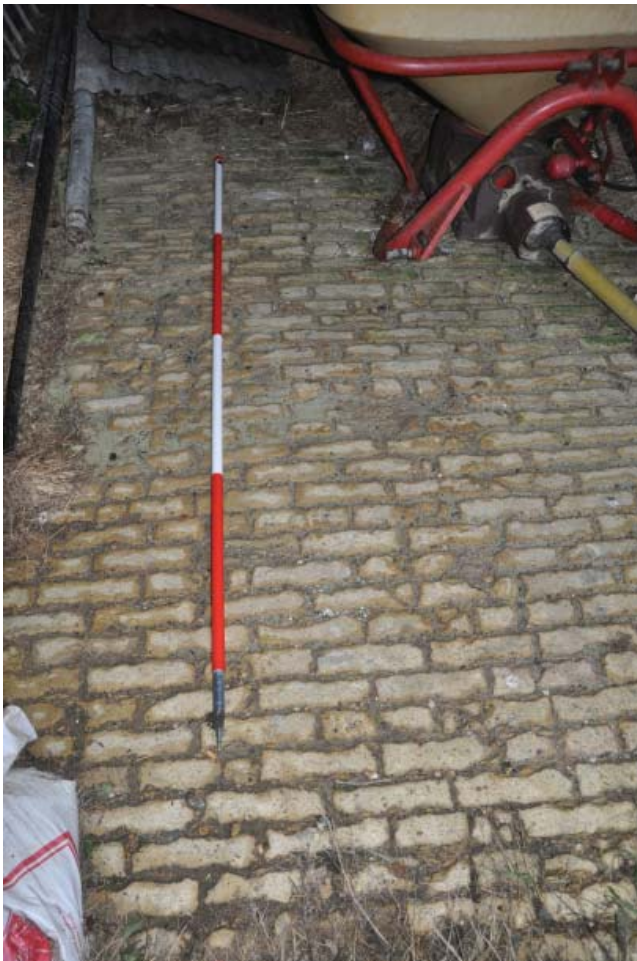
The floor of the barn largely consists of well-worn bricks. These vary both in terms of size and whether they are on their sides or laid flat. Some sample sizes of visible faces are 23cm x 7cm, 23cm x 10cm, 21cm x 5cm. The condition varies dramatically, some areas clearly being relatively modern and similar to the day they were built and some heavily worn with many years of constant use. It is difficult to discern any pattern or use divisions, as the floor of the barn was largely covered in mud, hay and detritus. It is clear from what is visible that there are at least some areas where the varied orientation of the bricks has been by design. Several patches of modern concrete repair were visible, as well as some that had been constructed to provide a base for the props that have been holding up the barn since 2008.

Sample of Flooring

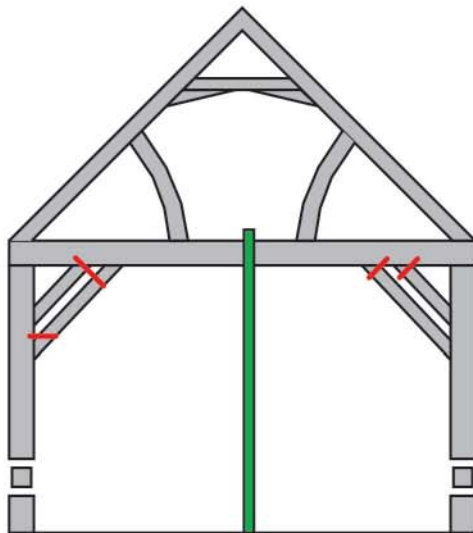
Truss 3

The barn's basic queenspost truss construction hasn't been altered greatly since it was constructed. One change that has been made is that trusses 3 and 4 have had the arch braces on the western side replaced with much smaller braces. These new braces are similar to a knee brace in form. I believe that this change was undertaken in the 19th Century. One possible explanation would be that the arch braces were in the way of the storage of a large piece of machinery, most likely a threshing machine.

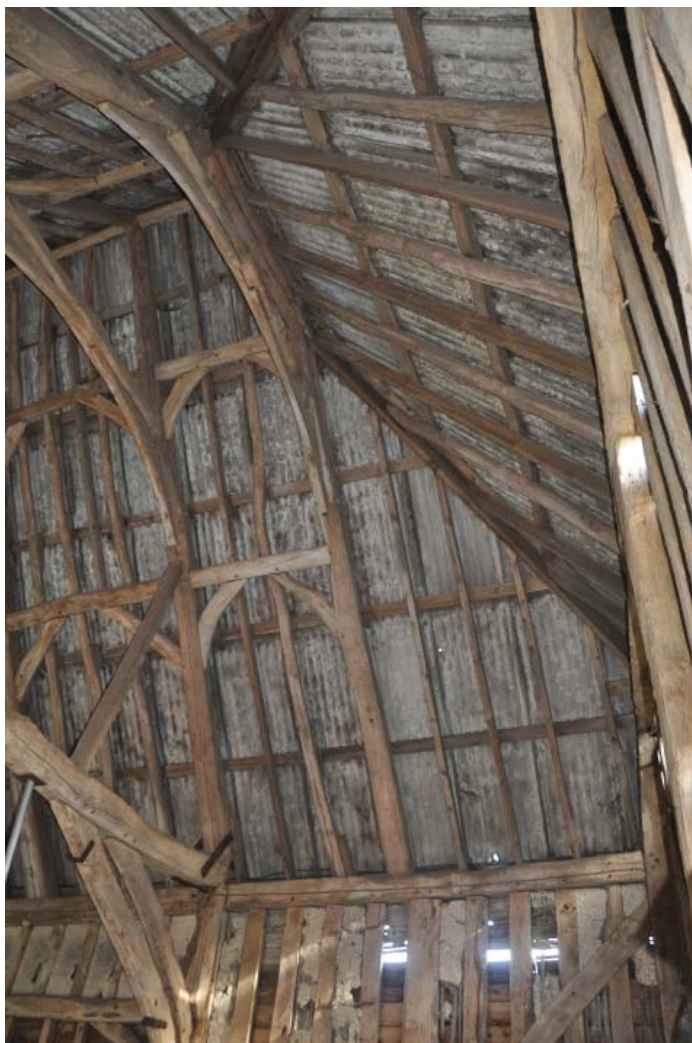
Bay 1- Roof Structure

The roof at either end is hipped with small gablets above. All the timberwork relating to the hipped roofs is 19th Century or modern machine-cut timber. It seems likely that the portions of roof at each end were either replaced like-for-like or that this was when the gablets were introduced, with a change in the angle of roof slope. It is quite likely that, as part of this phase of work, the roof was converted from thatch to corrugated iron.
